# Structural Site Visit Assessment Report for Trenton Central High School Trenton, NJ

Final Report – Revision 0

Report Prepared for: New Jersey School Development Authority

09/11/2014

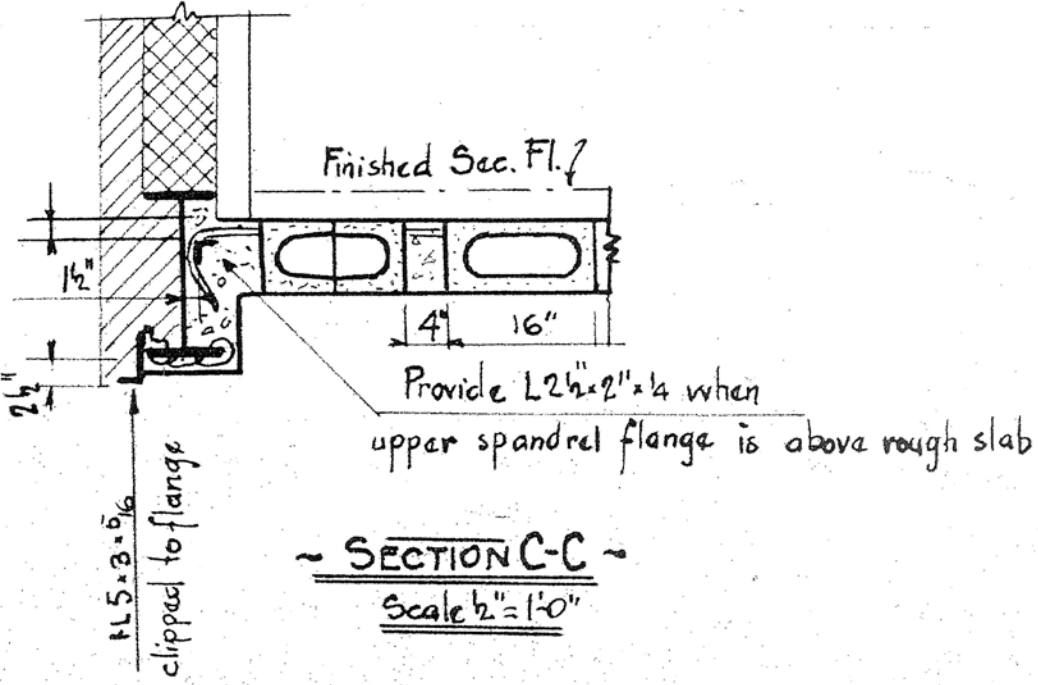
Figure 2

- Deviations from the original design drawings were noted in various places throughout the structure. The original floor system design shown on drawing S-A-3 indicates a masonry/concrete composite floor system (Figure 2); however a concrete pan and joist system was utilized almost exclusively throughout the structure (photographs [4] and [5]). A concern noted with the pan and joist system is the joists do not appear to bear directly on the concrete encased steel beams. It seems likely that reinforcing steel from the floor system may extend over top of the steel beams, which similar to the condition noted previously, is very unlikely to reveal an adequate analysis conclusion for support of dead and live loadings. A few areas utilized a one way slab with beams such as the auditorium floor and adjacent first floor level rooms to the south (photograph [6]), but the original floor system shown on the design drawings was not observed in any place during our site visit. Furthermore, several steel beams shown on the original design drawings were not installed in lieu of the concrete pan and joist system which runs parallel to the direction of the missing steel beams. This deviation from steel beams to concrete is troubling as it again brings into question the validity of the steel beam locations for the entire building.

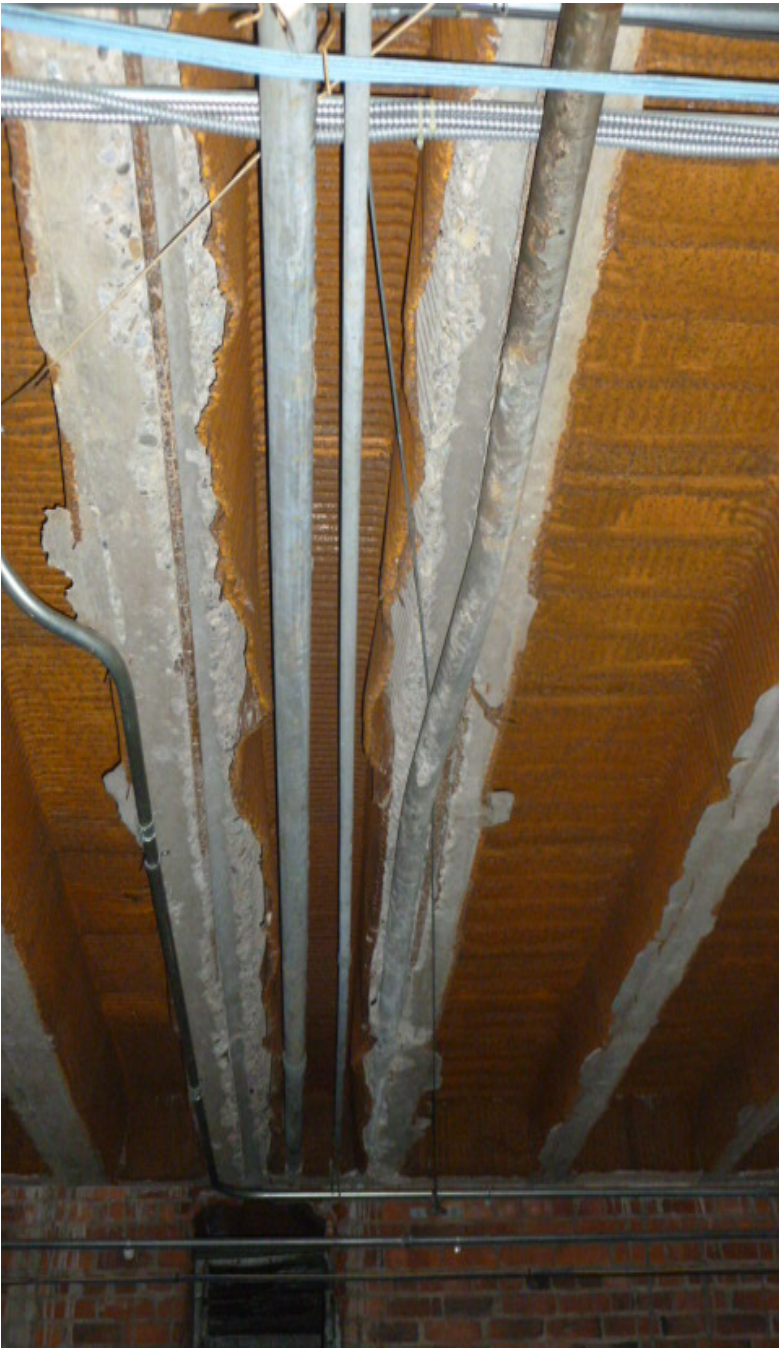
Photograph 1

- As shown in photograph [1], piping had been originally cast into the bottom of the forms adjacent to the tension reinforcement in two concrete joists supporting the main office room on the first floor. At some point the piping has dropped below the concrete in places along the joist and exposed the reinforcing. The reinforcing has experienced moderate corrosion and does not have bond with the concrete along almost the entire middle third of the span. Additionally, as shown in photograph [2], additional concrete has broken away from the floor joists and exposed the reinforcing for several joists located underneath the principal's office. Although we did not see signs of structural distress in the floor above at the time of our visit, we recommend these areas be repaired to their original capacity or permanently shored if the building is to be reoccupied.

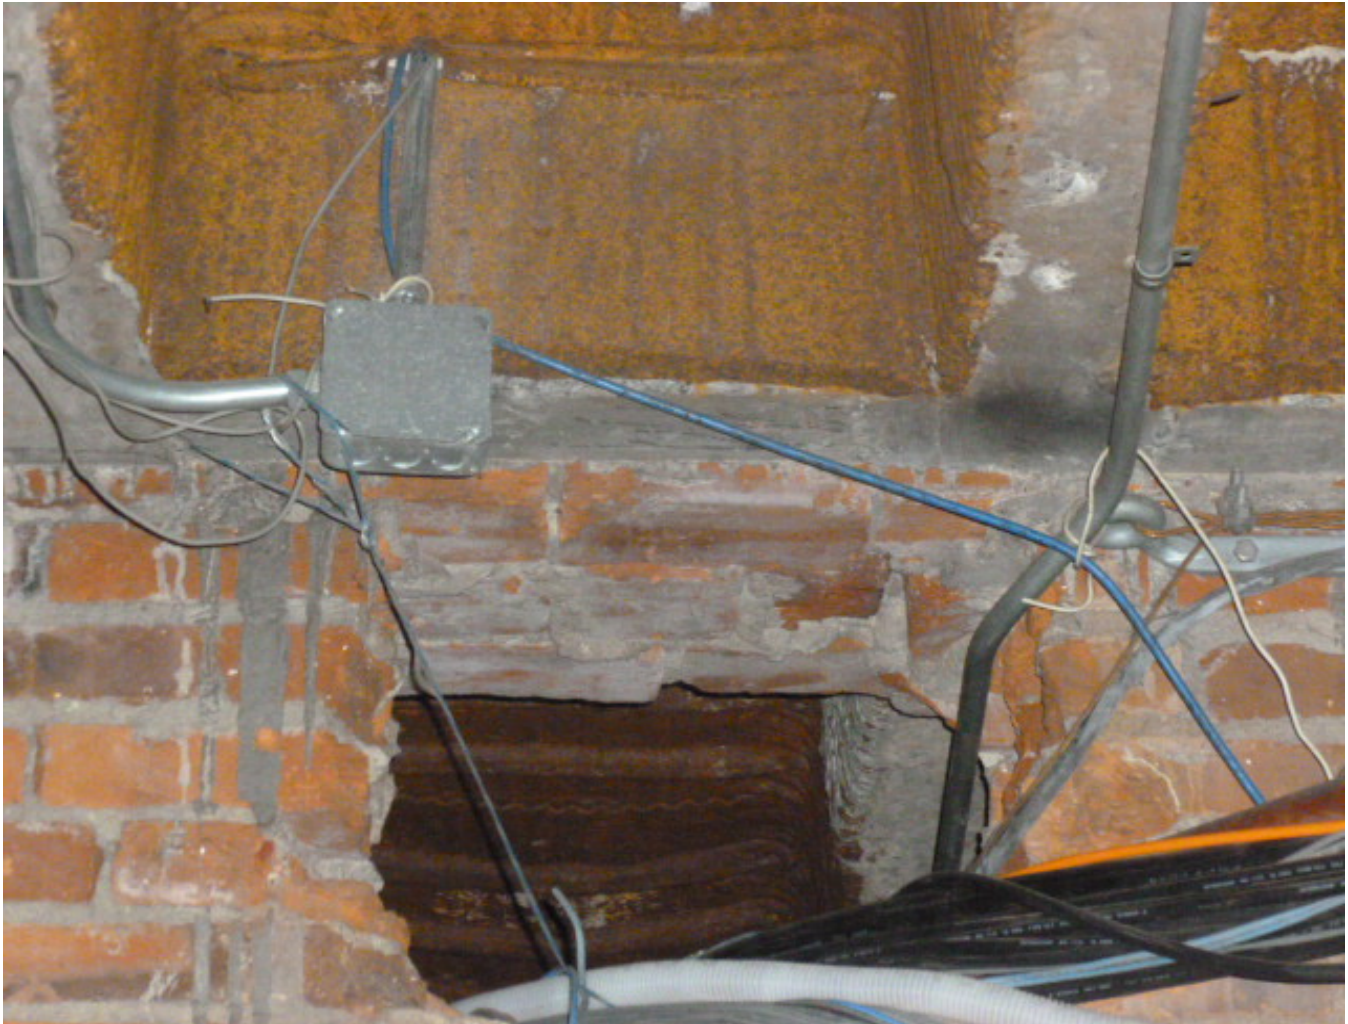
Photograph 3

- At two separate locations under the first floor main corridor of Building "A" which runs north and south, access holes in the bearing wall were observed at the junction of the concrete pan and joist system (photograph [3]). It appears the concrete joist do not have a bearing connection to this corridor wall, instead it is believed the reinforcing from the concrete joists penetrate the multi-wythe brick wall and provide a shear connection only to this wall. The reinforcing steel cannot bond with the multi-wythe brick wall and must act as a physical "seat" to support the load from the concrete joist. This reinforcing which is assumed to penetrate into the multi-wythe wall must also serve as a connection for the floor diaphragm to distribute all lateral loads into this wall as well. This particular method of construction causes specific concern due to the past water infiltration problems and possible corrosion of the reinforcing steel. Since the floor construction does not appear to interrupt the multi-wythe brick bearing walls, the only means of support is the aforementioned reinforcing which is assumed to exist at these locations. It is highly unlikely that any type of analysis would reveal the assumed reinforcing to be adequate to resist dead and live loadings, much less transfer lateral loads to these walls.

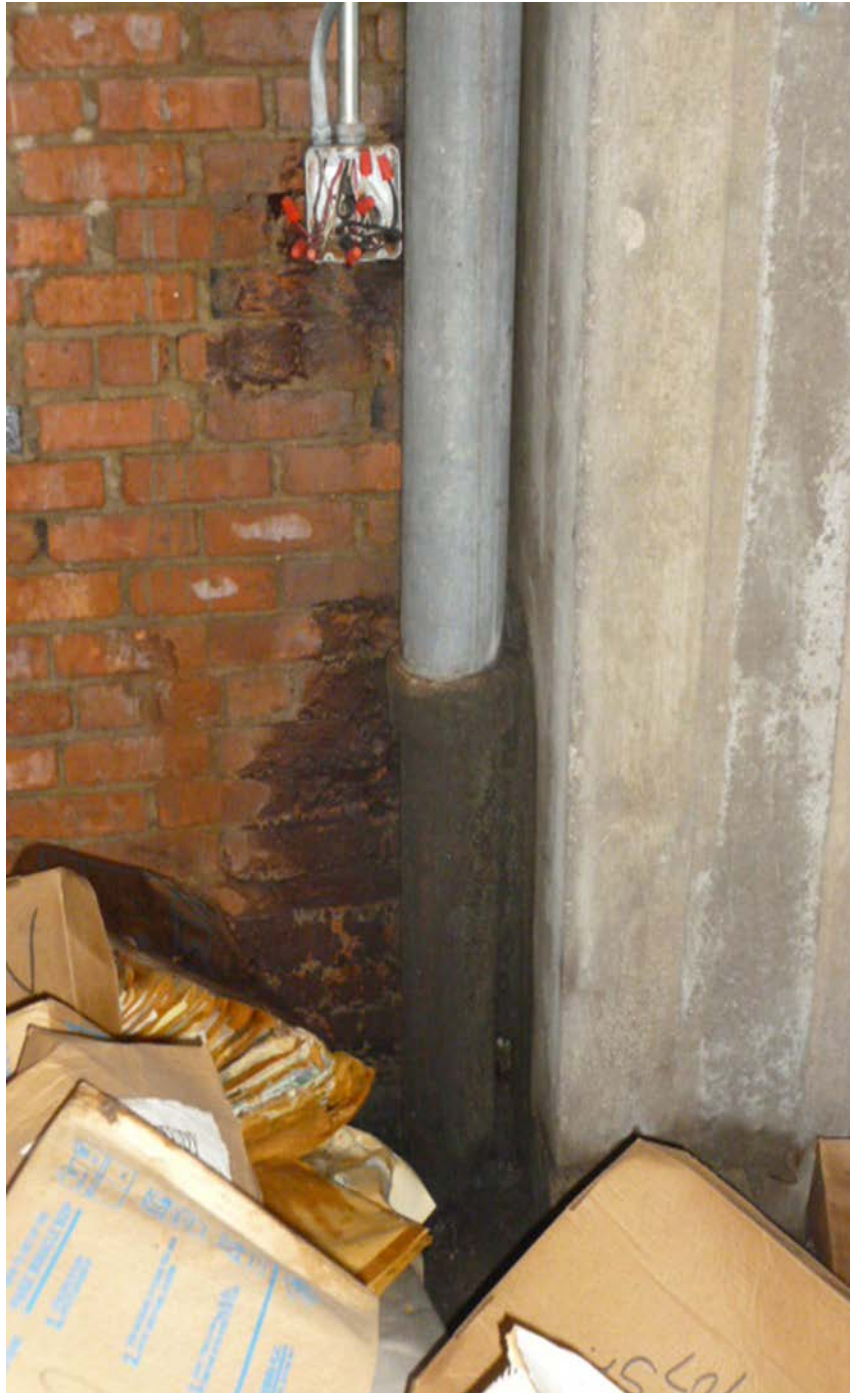
Photograph 9

- A rain water leader along the north wall underneath the auditorium was either clogged or had burst and allowed water to collect on top of the slab-on-grade (photographs [9] and [10]). If the rainwater is allowed to wash underneath the existing foundations, localized settlement can occur. We recommend replacing the rain water leader and clearing of any subgrade clogging which may have occurred should the building be reoccupied.

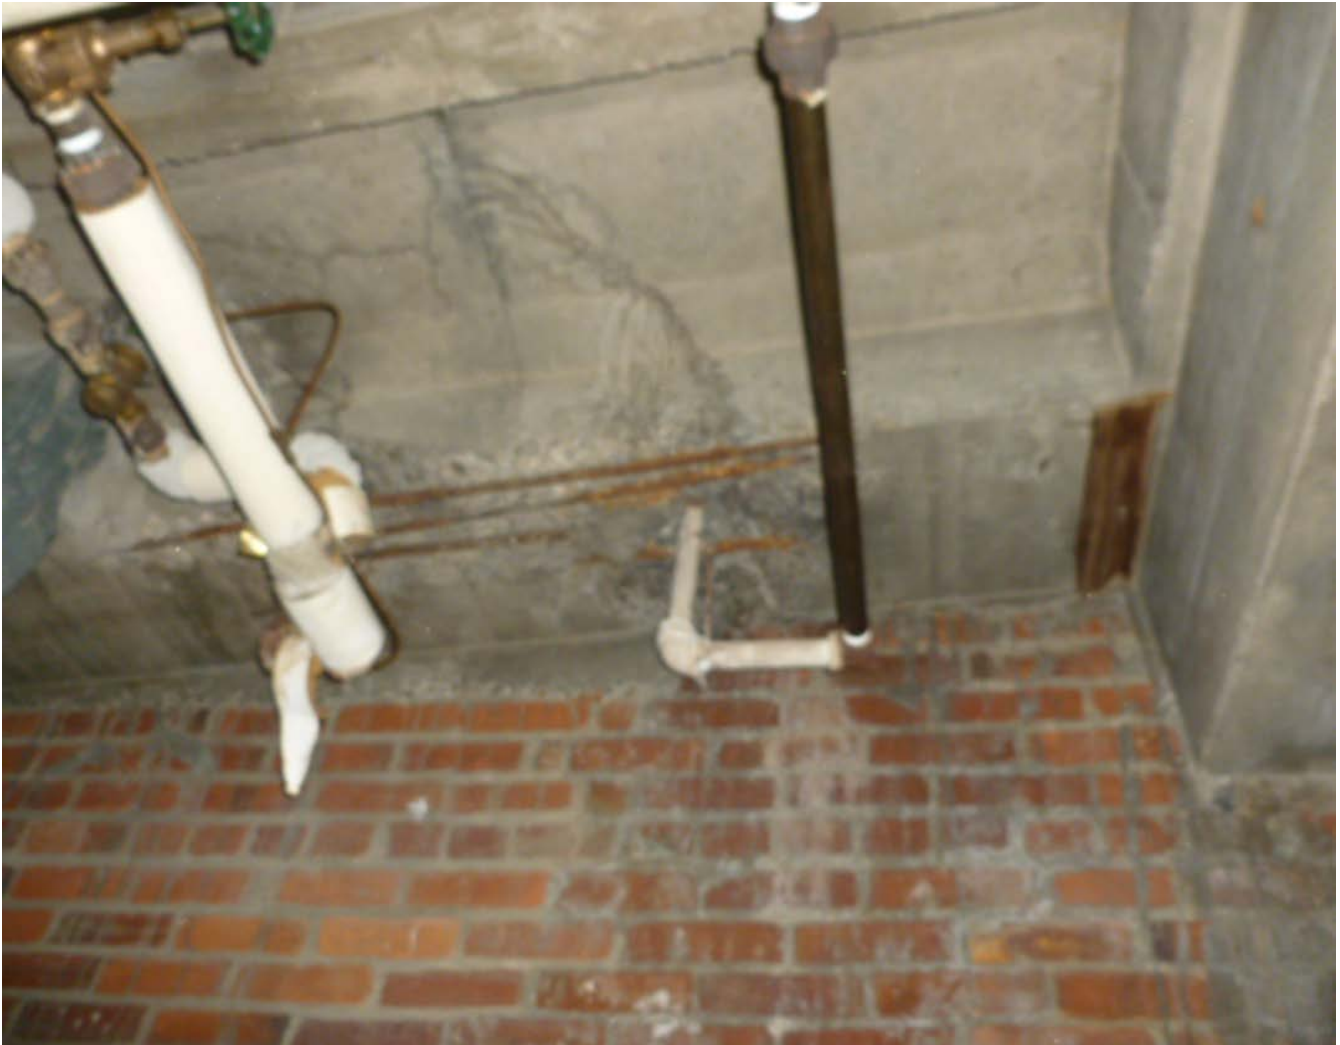
Photograph 12

- Spandrel beams running parallel to the south wall of the exterior auditorium wall have exposed reinforcing bars with moderate corrosion in several locations (photograph [12]). At one location along the spandrel beam near a concrete encased steel column, a rainwater leader enters the interior space interrupting the spandrel beam at its connection point to the column (photograph [13]). Although we did not view any structural distress along the spandrel beam at the time of our visit, the original design strength of the spandrel beam has been compromised and will continue to decline as the corrosion of the reinforcing steel increases over time. We recommend relocation of the existing piping and a permanent shoring system be installed underneath this spandrel beam.

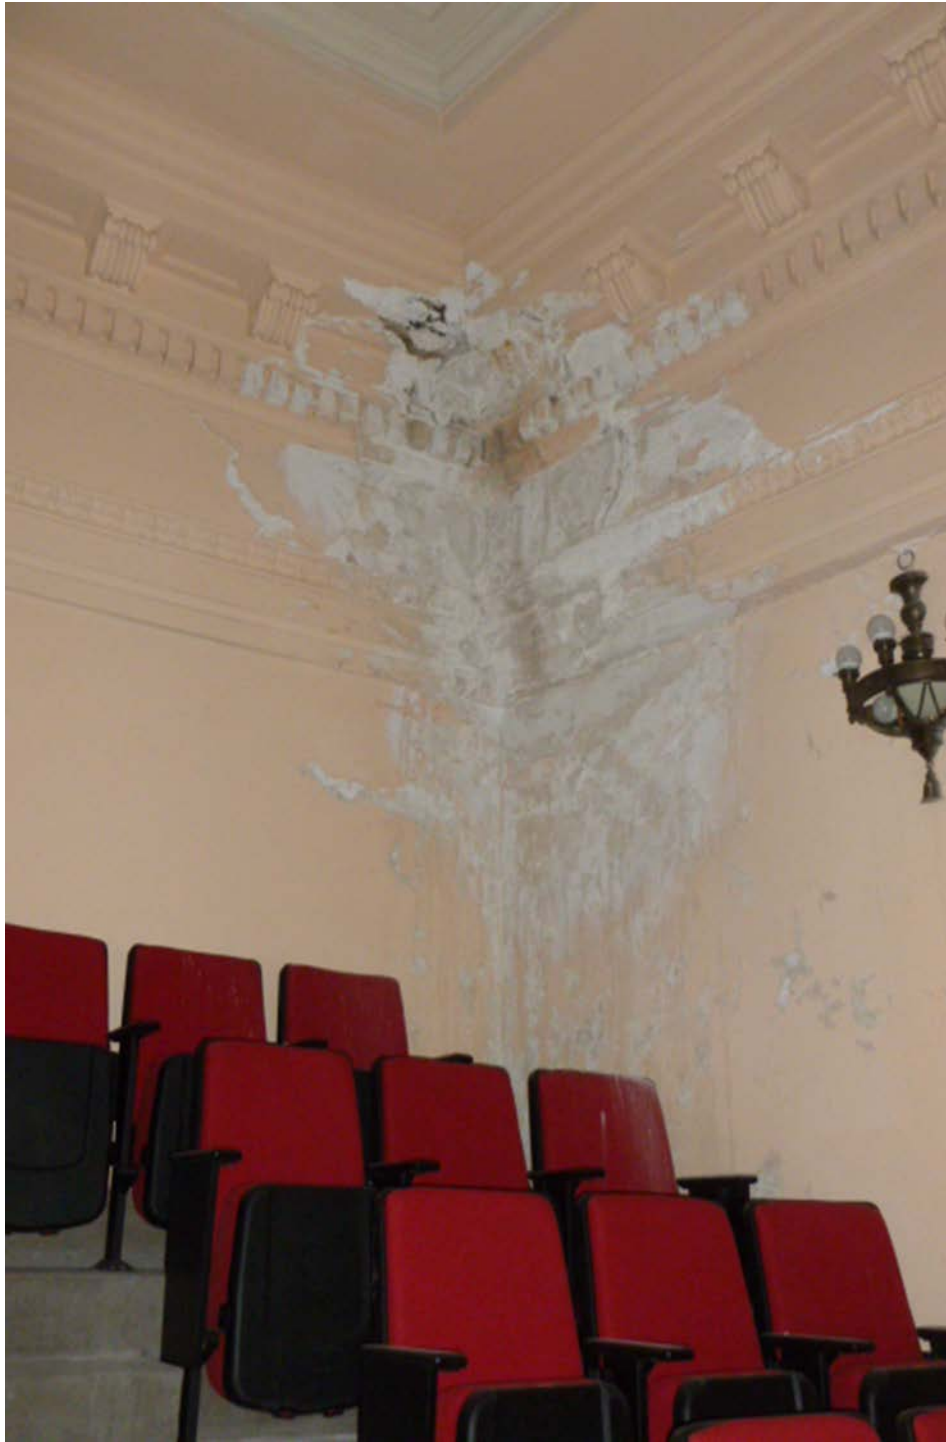
Photograph 15

- Interior water damage was observed in both rear corners of the balcony with the worst damage noted in the northwest corner (photograph [15]). We could not access the structure behind the damaged plaster at the time of our visit; however each area should be investigated for any potential structural damage due to corrosion.

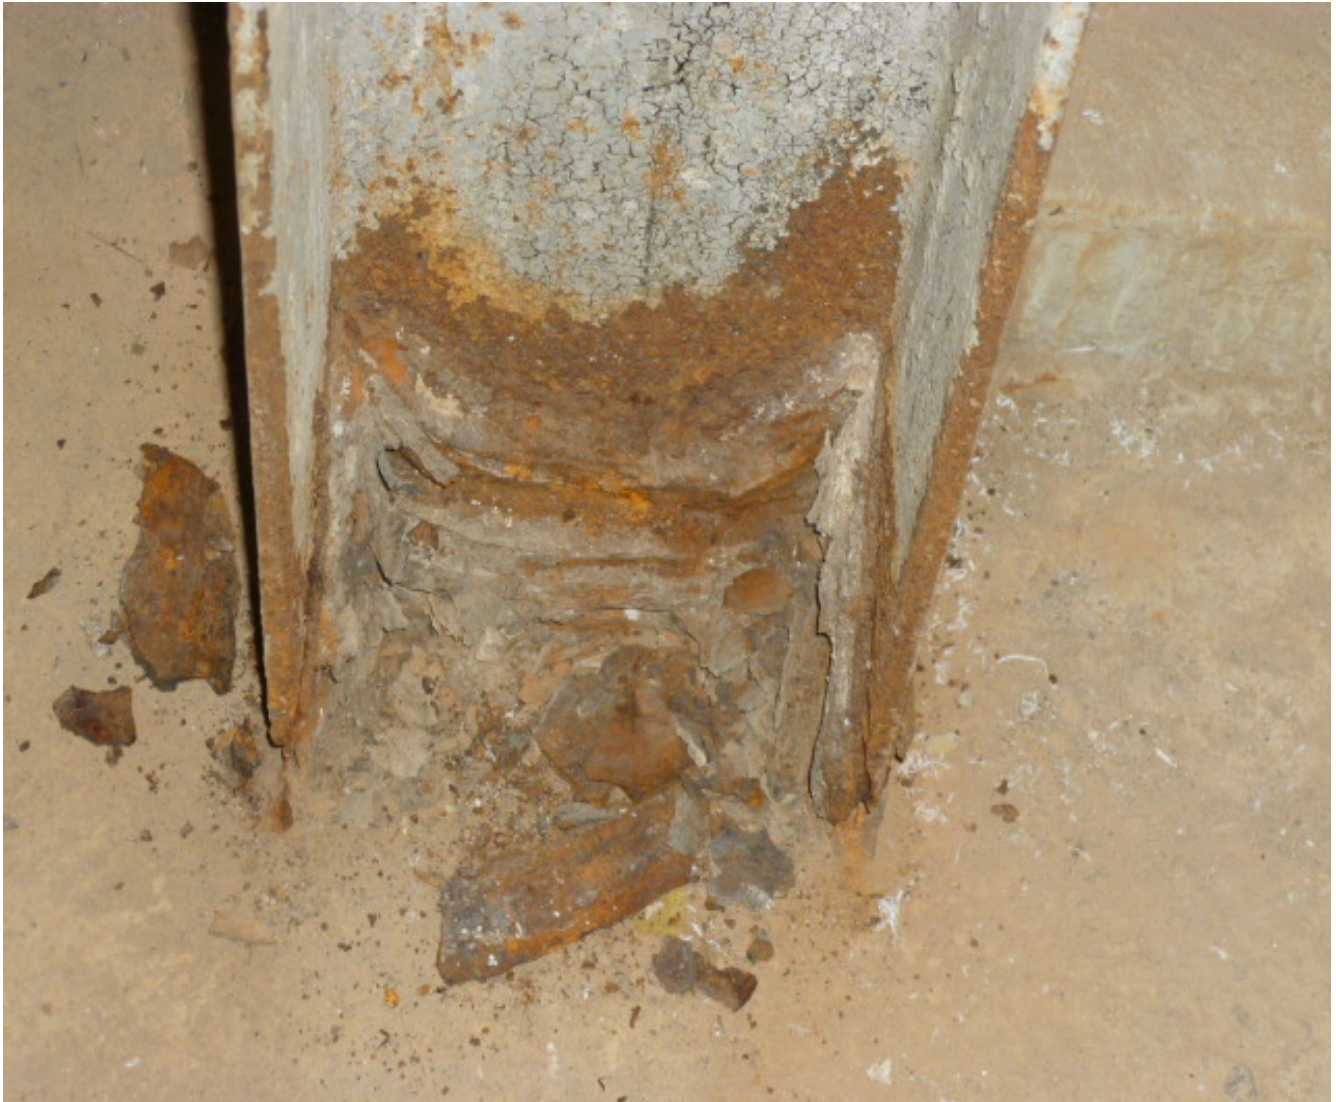
Photograph 20

- Two structural steel columns on the north side partial basement were not encased in concrete and severe corrosion was observed at the junction of the column to the concrete floor (photograph [20]). Although no structural distress was observed at the time of our visit, the load capacity of these columns has been seriously degraded by the corrosion and we recommend either a repair or replacement of these columns should this area of the structure remain.

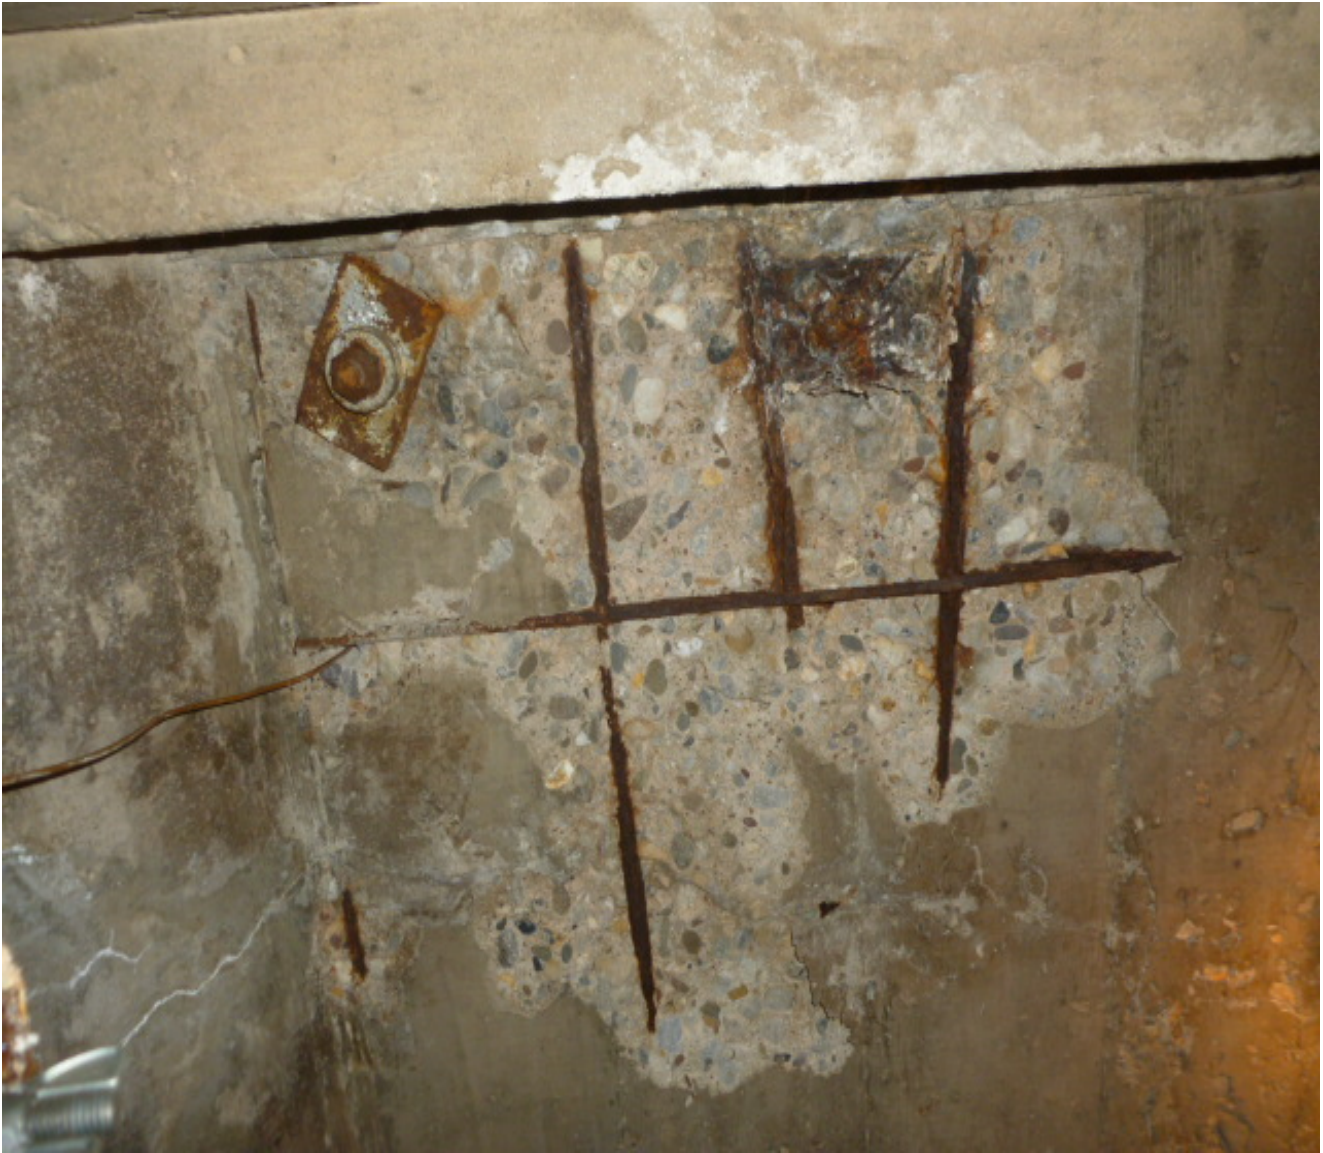
Photograph 21

- We observed several concrete joists to the south of the pool with spalled concrete and exposed reinforcing ranging from light to moderate corrosion (photograph [21]). We recommend these joists be repaired if this portion of the structure is to be retained.

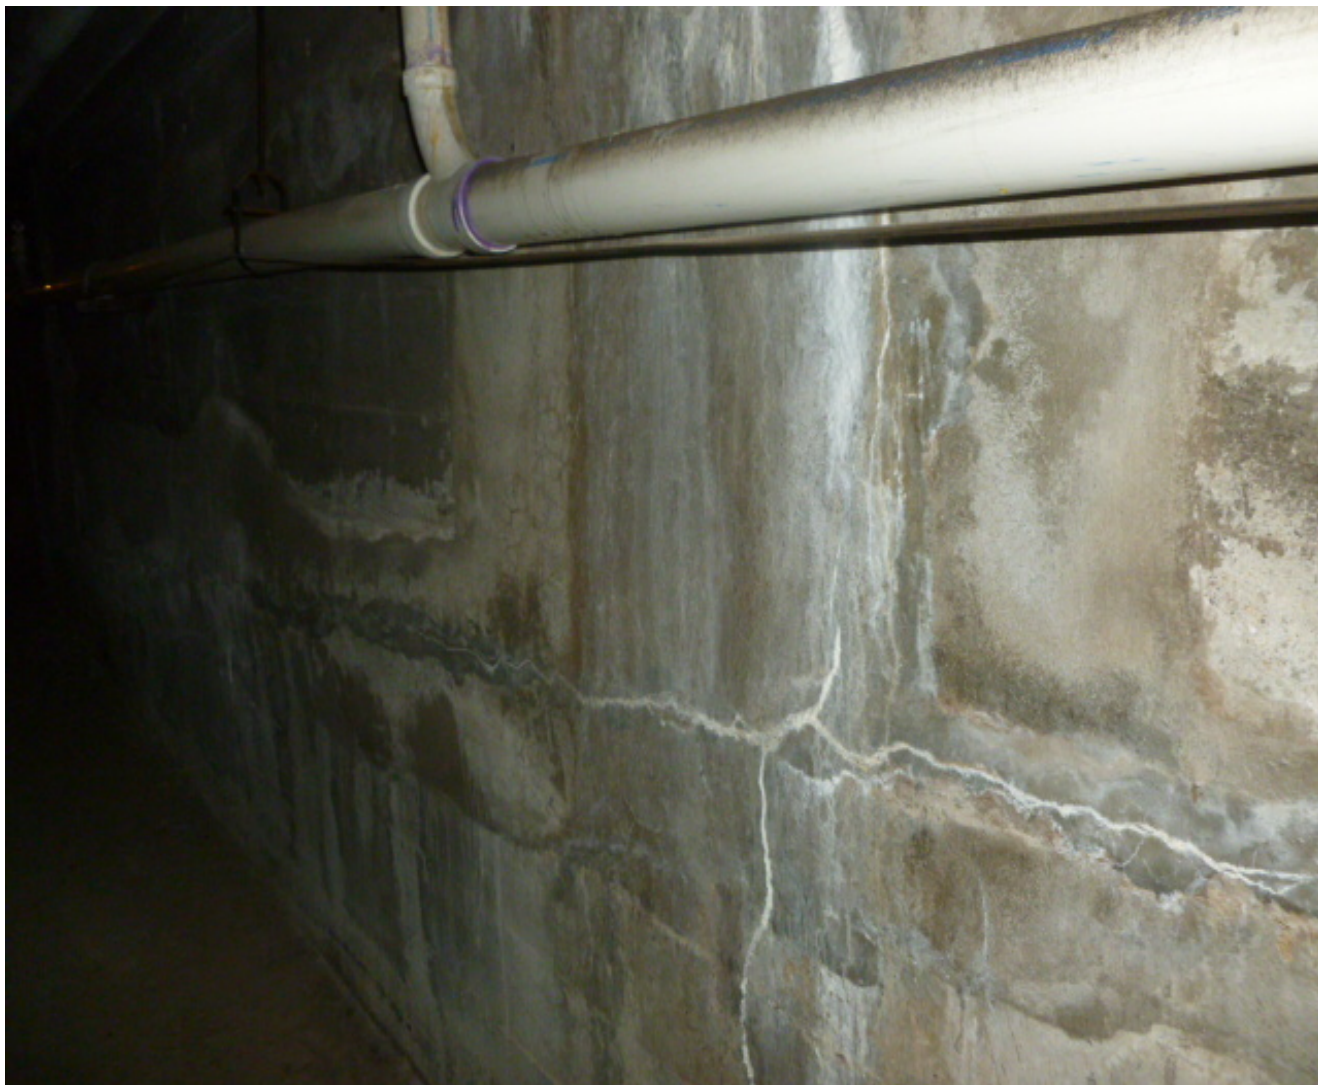
Photograph 22

- Several diagonal to horizontal cracks were observed to have been patched along the east wall at the pool itself (photograph [22]). It appears these cracks follow the break in between two subsequent concrete pours when the wall was originally constructed. While we do not have information regarding when the patching took place, some cracks have extended beyond the extent of the patchwork. We recommend additional patching/repair and a monitoring program should the pool remain.
